## R434A (RS-45) SIMPLIFIES RETROFITS

### RETROFIT CASE STUDY

Location: FRUTAS RONCAL-LANA in Épila (ZARAGOZA)  
Contractor company: INDUSTRIAL LERIDANA DEL FRÍO S.L.  
Date: January of 2010

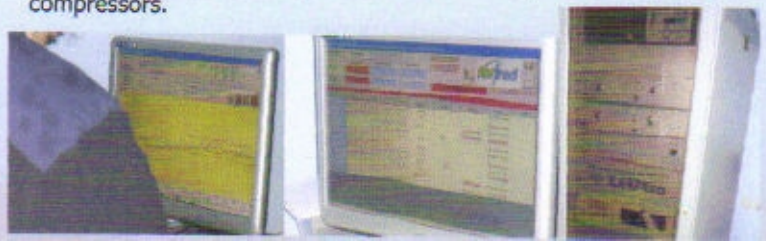
The installation is monitored and computed with temperature probes, pressure, humidity and electric consumption control of the compressors.

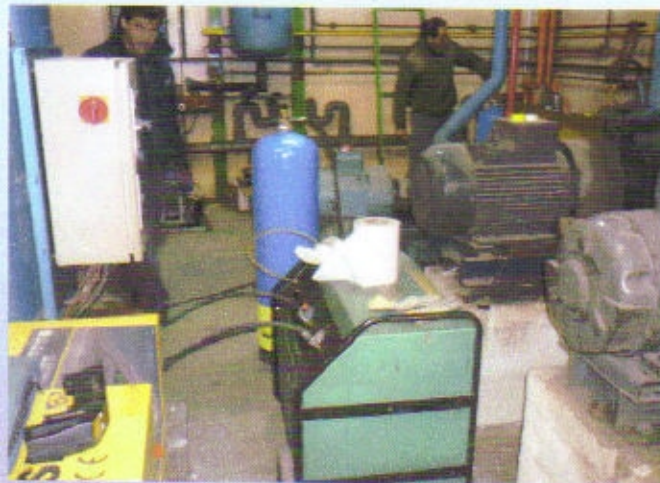
The next day a drop in the oil level was detected in the crankcase of the compressor. Checked that the oil was not located in the cold parts of the installation areas (evaporators), but was found to be distributed throughout the installation. Because of this, ILERFRED decides to change the oil separator for a more efficient one, and achieves the normal levels.
